June 1983

Site Investigation Syosset Landfill Oyster Bay, New York

Peter M. Stokely, Imagery Analyst

**ENVIRONMENTAL MONITORING SYSTEMS LABORATORY
OFFICE OF RESEARCH AND DEVELOPMENT
U.S. ENVIRONMENTAL PROTECTION AGENCY
LAS VEGAS, NEVADA 89114**

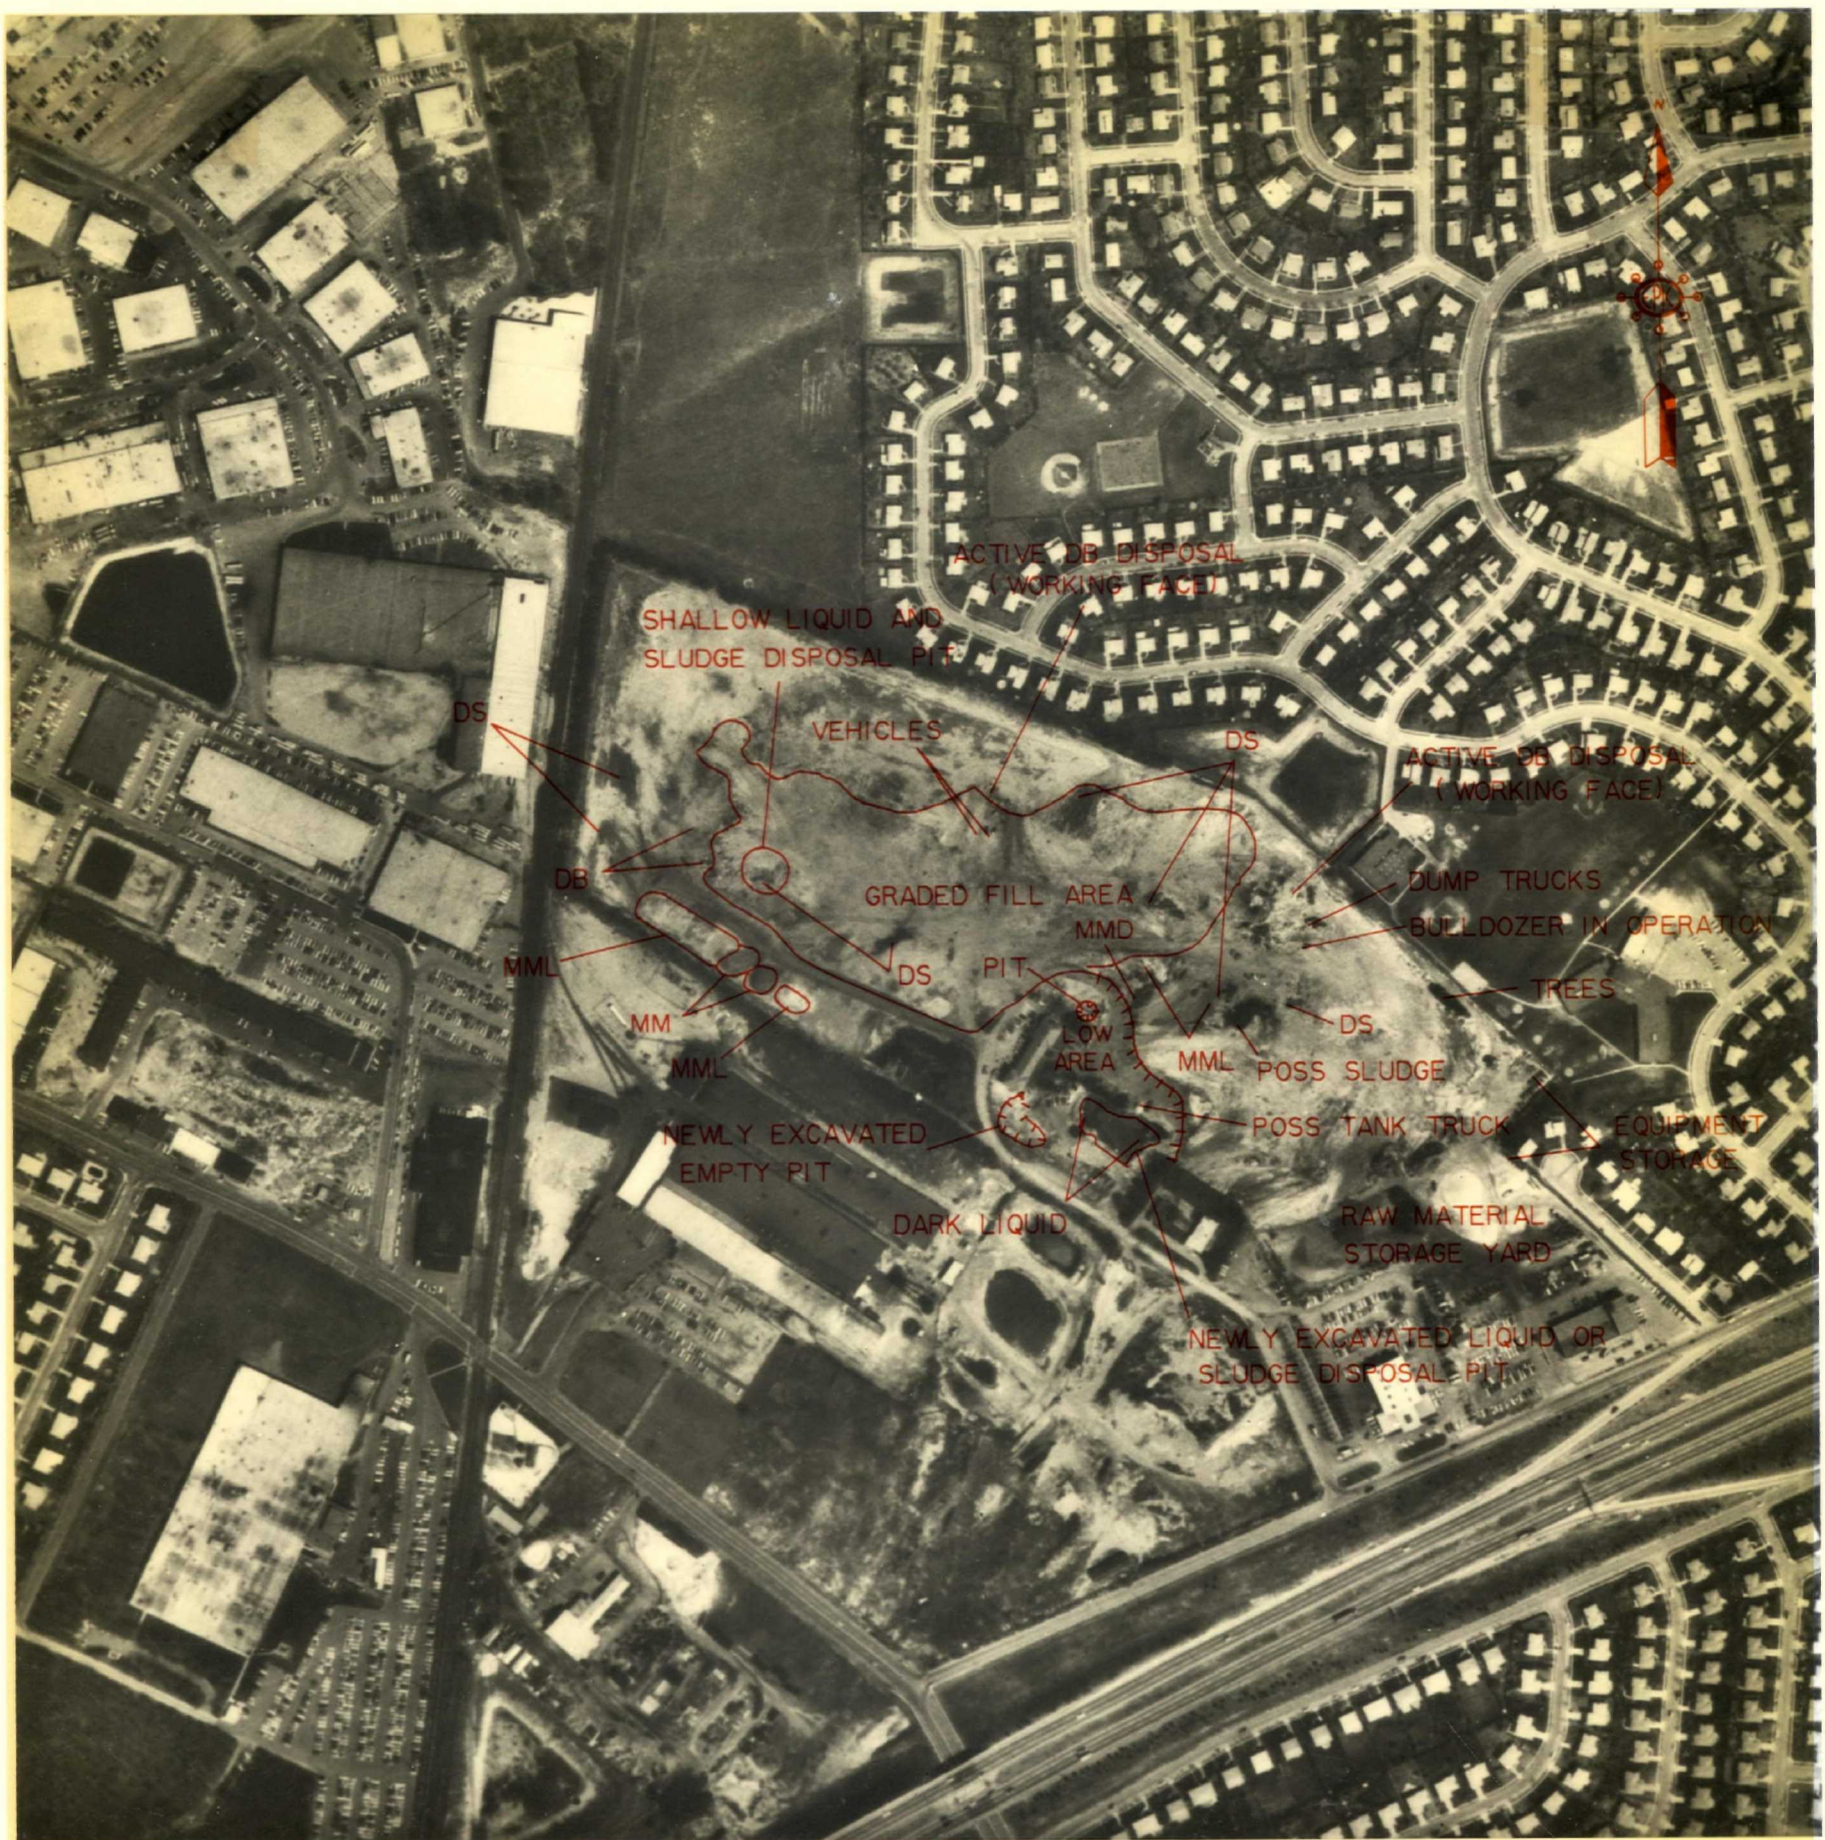
PHOTO 7 SYOSSET LANDFILL MAY 5, 1966 APPROX SCALE 1:5,000

Extensive landfilling has taken place since 1963. The 14-17 meter (46-56 feet) deep eastern excavation area first seen in 1959 has been completely filled with light-toned fill. Most of this filling occurred after 1963. The only large area that has not been filled to or above the level of the surrounding unexcavated land is the low area east of the incinerator building. This area remains below the grade of the rest of the fill through the last year of analysis (1983). Active landfilling continues on site, as evidenced by the presence of debris (DB) piles, recent dark staining (DS), mounded material (MM) and vehicular activity on site. Active debris disposal can be seen in the north central and northeastern sections of the site. Dump trucks and an operating bulldozer are present at the working face of the northeastern dump site.

The liquid and sludge disposal pit found in previous years is shallow and barely visible in 1966. Some dark staining (DS) is visible in the shallow remains of the pit. Graded fill is visible around the pit and over a large portion of the center of the site. Partially covered debris (DB) is visible along the western edge of the fill. Mounded material (MM) and light-toned material (MML) are visible along the southern edge of the site. Dark staining (DS) is visible in the western portion of the site and on several areas of the graded fill area covering the center of the site.

A newly excavated, probably unlined pit filled with liquid and sludge is located west of the incinerator building. Dark-toned liquid can be seen at either end of the pit, while a lighter-toned residue appears in the center of the pit. A possible tank truck is parked north of the pit. The junked equipment seen in 1963 has been removed. A newly excavated empty pit is located at the southeast corner of the incinerator building. Another smaller empty pit is located at the northeast corner of the incinerator building.

Light- and dark-toned mounded material (MML and MMD), possible sludge and some dark staining (DS) can be seen on the light-toned fill that covers the eastern excavated area.

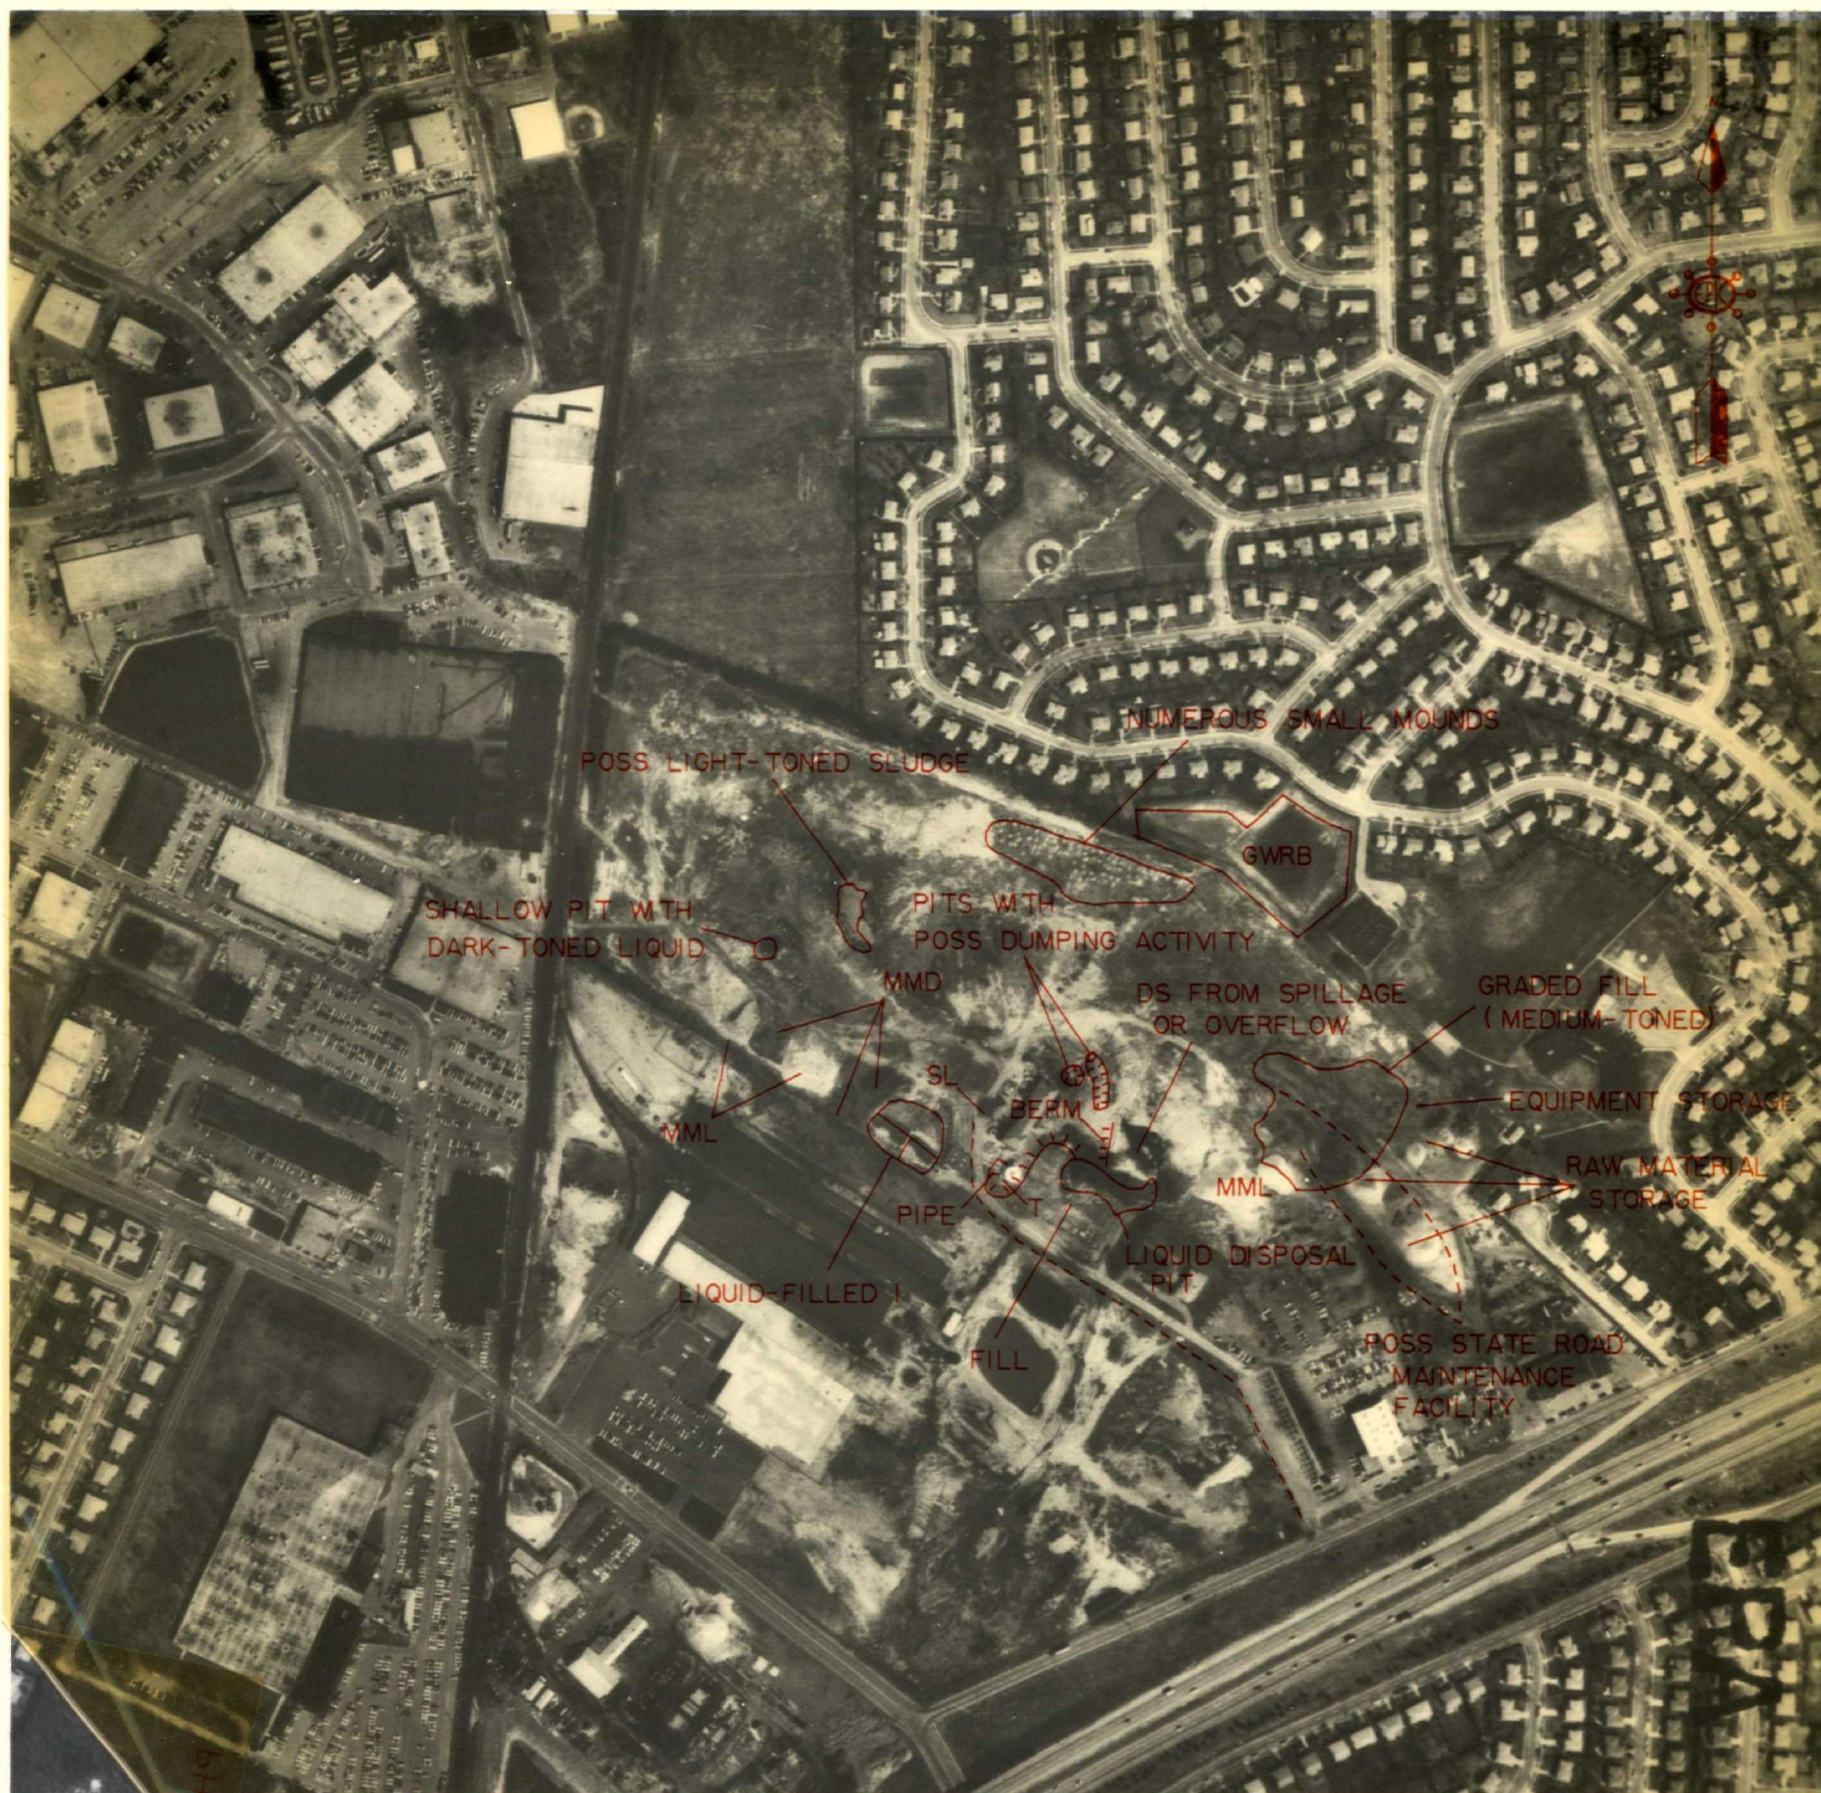
8 SYOSSET LANDFILL APRIL 11, 1969 APPROX SCALE 1:5,100

A cylindrical tank (T) has been erected in the empty pit that was located just south of the old incinerator building in 1966. A pipe leads westward from this tank and possibly goes underground toward the three-sectioned impoundment. The pit east of the old incinerator has been partially filled from the south and contains very dark-toned liquid or sludge. Dark staining (DS), resulting from a spillage or overflow, can be seen north of the pit. A berm has been constructed next to the spill to block further overflow. Mounded light-toned material (MML) can be seen east of the liquid-filled pit. Two pits with possible dumping activity can be seen near the northeast corner of the incinerator building.

The raw material storage is associated with a possible state road maintenance facility located at the eastern edge of the landfill. Medium-toned fill is being graded over the eastern portion of the landfill just west of the raw material storage area. Access to this graded fill is from the east, through the raw material storage area.

- 1969 - (Photo 8) The liquid disposal pit next to the incinerator appears to have overflowed in 1969. Dark staining (DS) can be seen where the spillage occurred. A berm was constructed to block further spillage. A tank (T) has been erected in an empty pit next to the incinerator. A three-sectioned impoundment has been constructed west of this tank. A shallow pit with dark-toned liquid occupies the position of the liquid/sludge disposal pit seen in previous years. Light-toned liquid or sludge has been spilled on the central portion of the site. This spillage remains unchanged for at least nine years (until 1978). Vegetation appears to be encroaching on parts of the landfill.

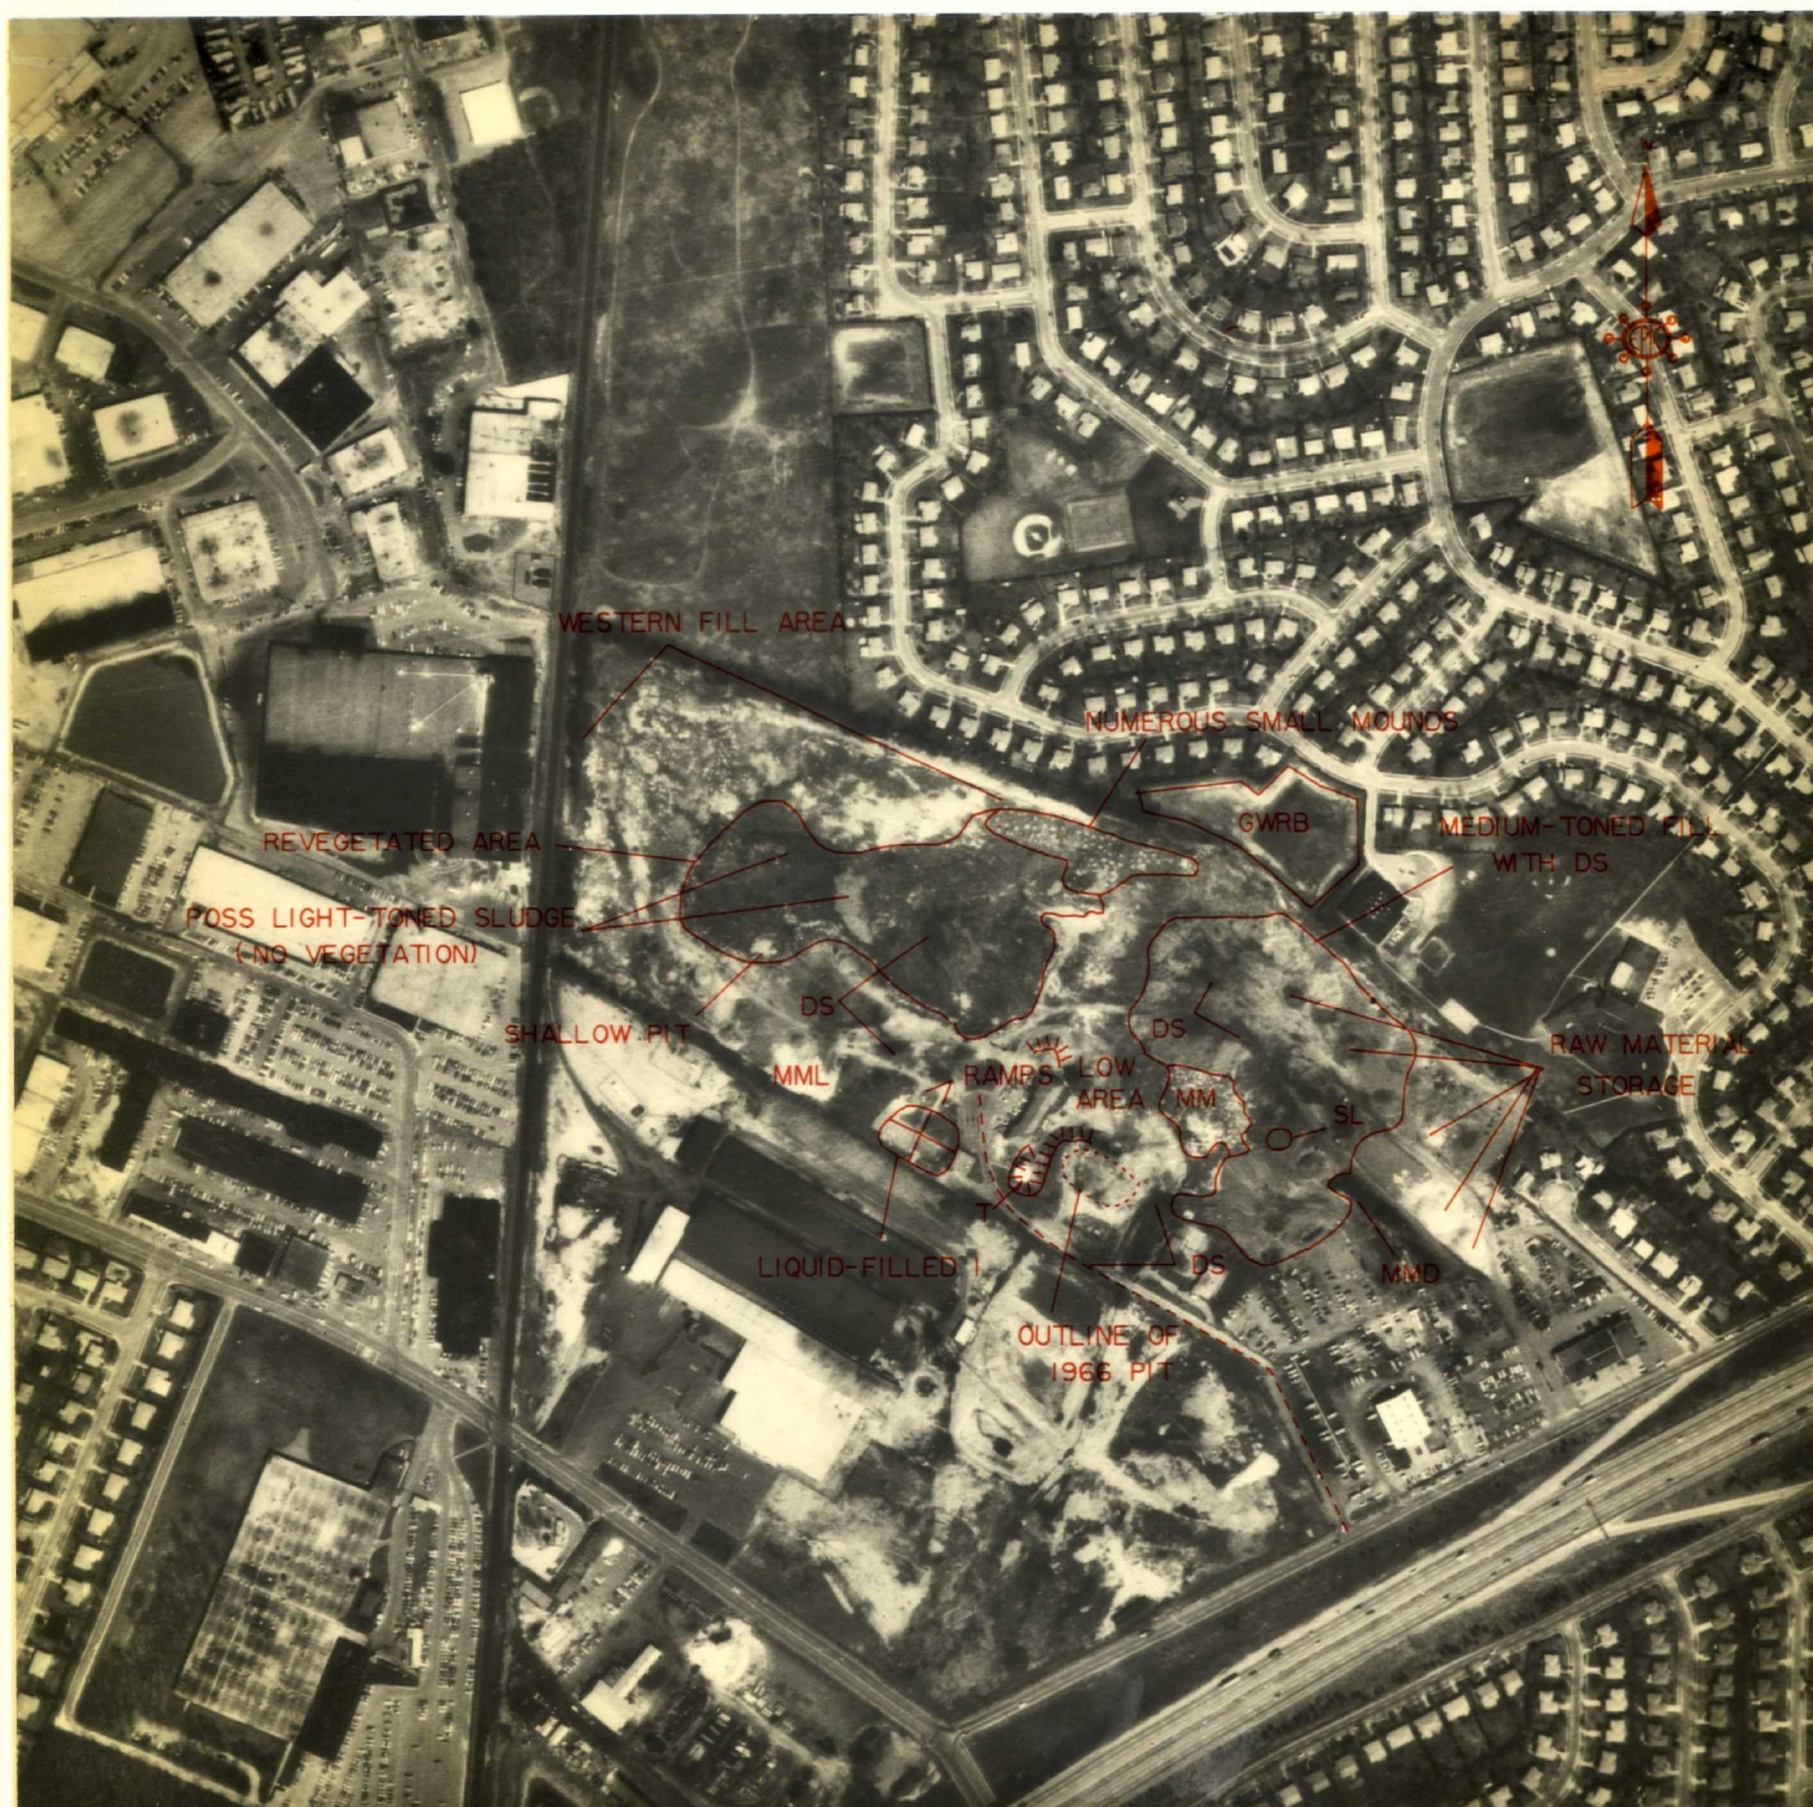
PHOTO 9 SYOSSET LANDFILL APRIL 18, 1972 APPROX SCALE 1:5,100

The western portion of the landfill is similar in condition to that seen in 1969. Partial revegetation is visible, and the numerous earthen mounds and shallow depression are still visible. The shallow pit is also still visible, but it now contains light-toned material. Two areas of dark staining (DS) are visible to the east. The light-toned sludge or cement is still visible.

The impoundment (I) along the south edge of the site contains four chambers and appears to hold both light and dark liquid. Two ramps lead into this impoundment. The tank (T) near the old incinerator building is still present. The liquid-filled pit seen east of the old incinerator has been filled by 1972. The historical boundary (1966) is outlined on the photo overlay. Areas of dark staining (DS) can be seen east and south of the old pit. Some of this staining appears to have flowed into the access road leading on site.

Medium-toned fill with some dark staining (DS) has recently been spread over the eastern portion of the landfill. Dumped mounded material (MM) and standing liquid (SL) are located adjacent to and partially surrounded by this fill. The raw material storage area has expanded westward onto this fill area.

- 1972 - (Photo 9) The liquid disposal pit first seen in 1966 has been filled by 1972. Dark staining (DS) can be seen where the pit was located. The sectional impoundment west of the incinerator contains four sections with both light-and dark-toned liquid and two access ramps visible. The raw material storage facility is expanding westward onto the landfill.

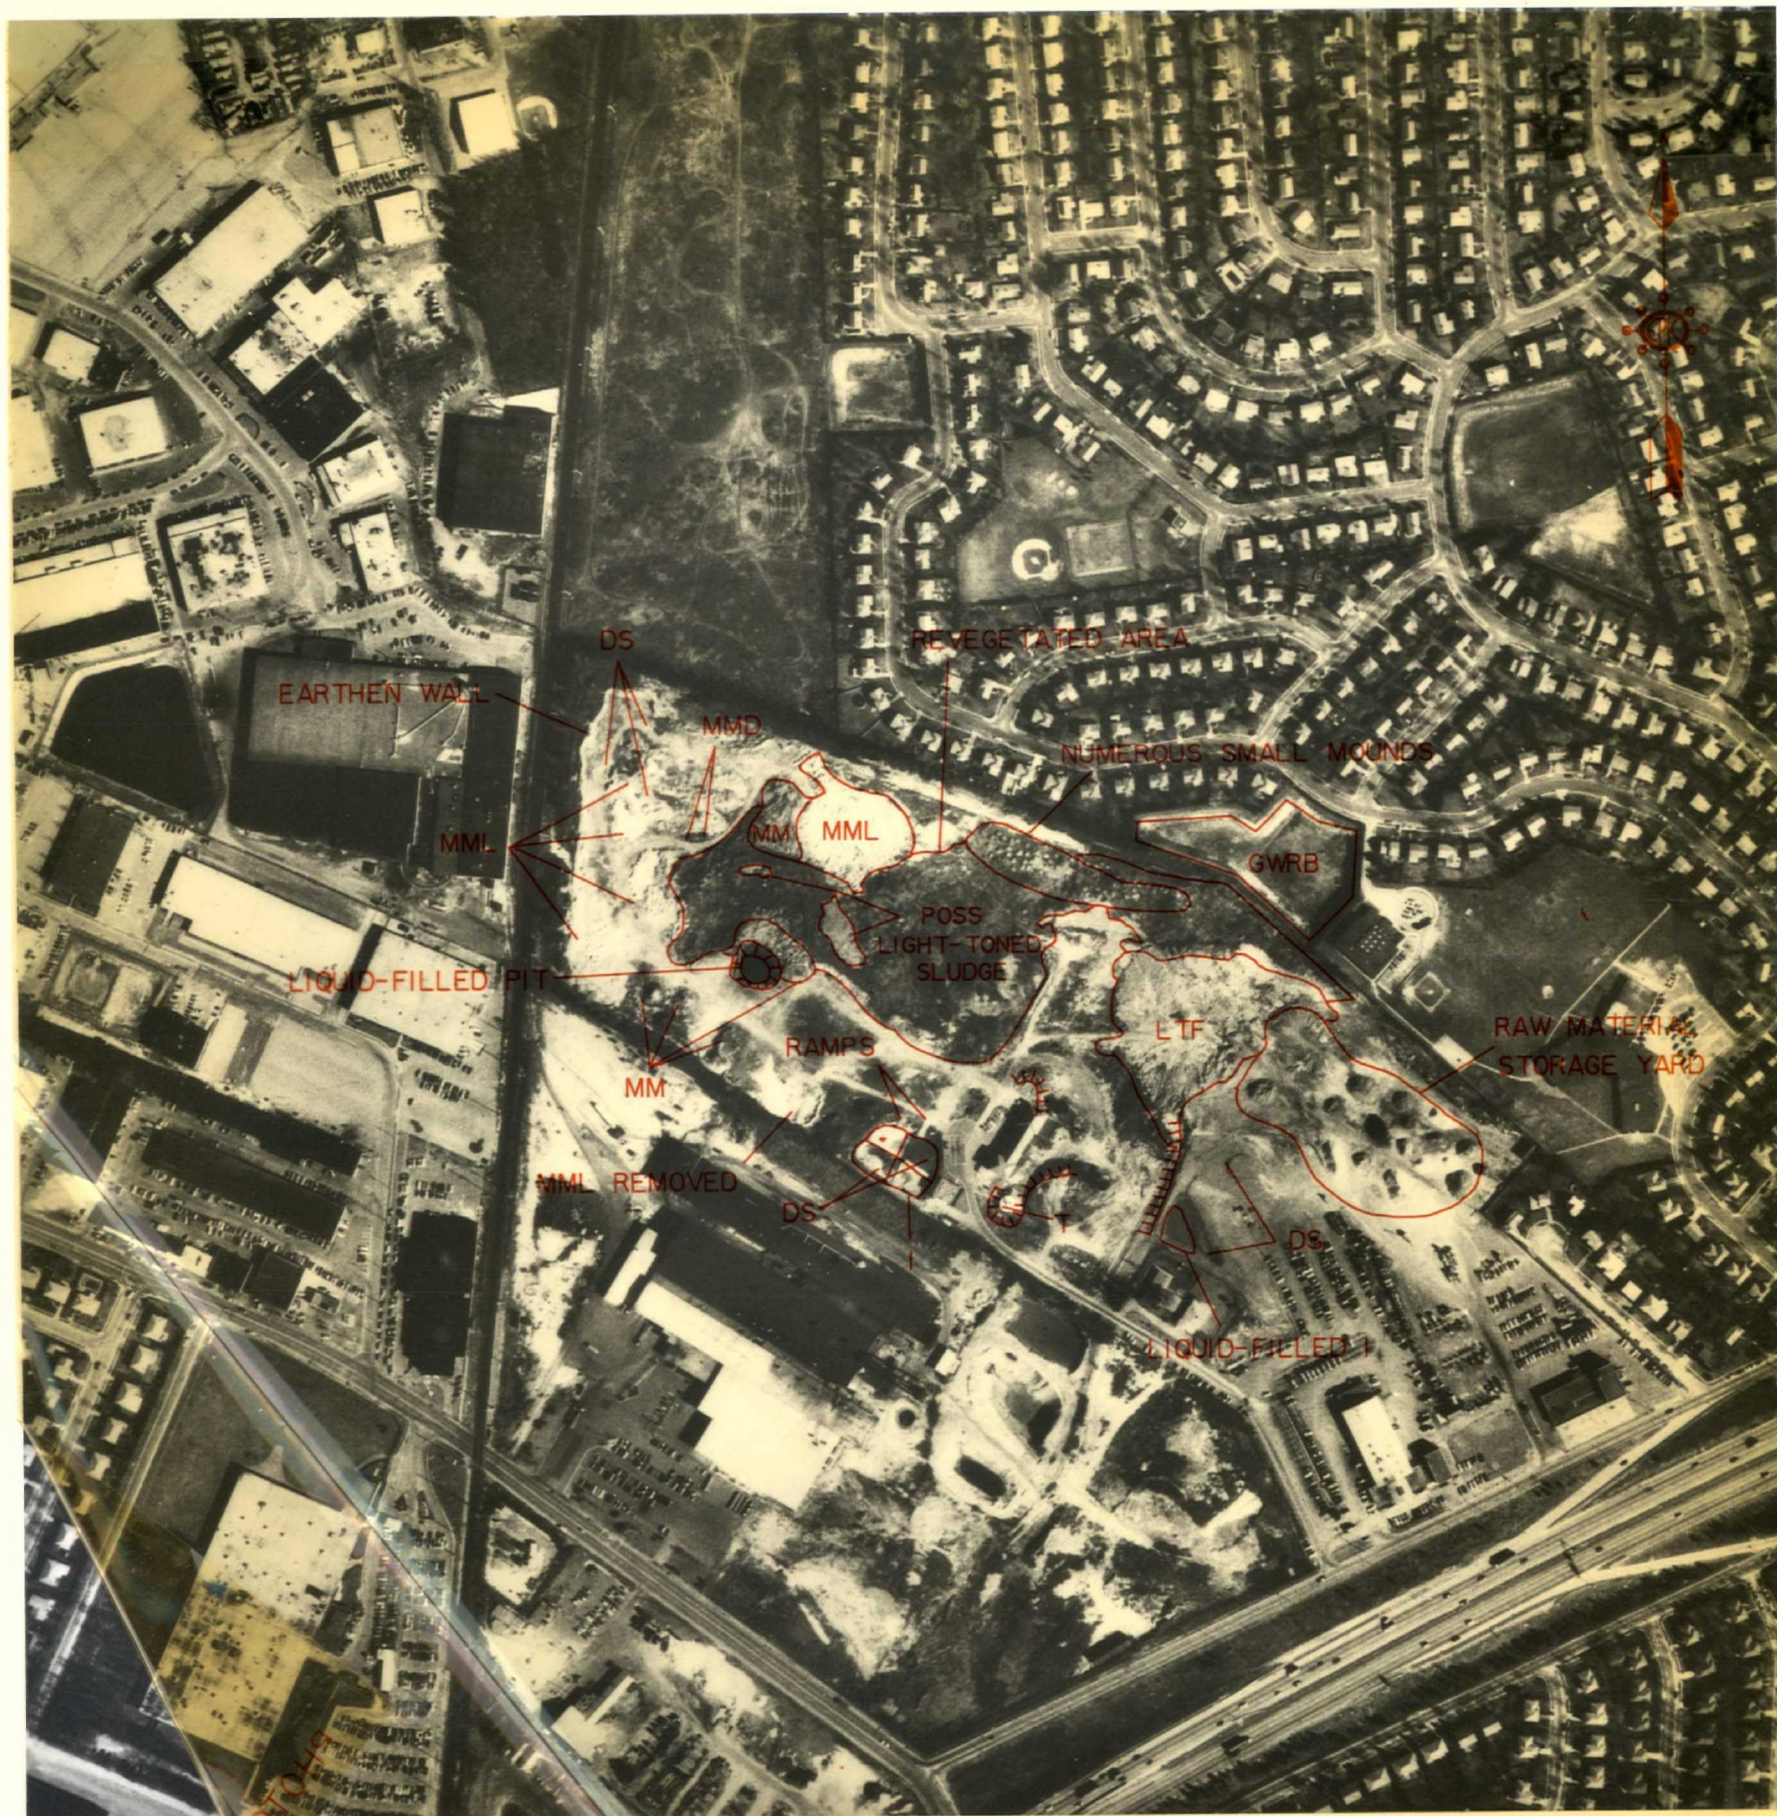
SYOSSET LANDFILL MARCH 14, 1974 APPROX SCALE 1:5,000

Dark staining (DS) can be seen in two sections of the four-sectioned impoundment and among the light-toned mounded material (MML) at the upper northwest corner of the landfill site.

Light-toned fill (LTF) continues to be spread in the eastern portion of the landfill. A small (0.04 hectare--0.1 acre) impoundment (I) with liquid has been constructed east of the old incinerator building. Two areas of dark staining (DS) can be seen east and north of this impoundment. The raw material storage yard and the maintenance facility continue to expand westward onto land that once comprised the eastern excavation.

- 1974 - (Photo 10) New ground disturbance and fill activity have taken place in the western section of the site. The pit near the historical sludge disposal pit has again become more pronounced; it now contains dark liquid. Light-toned fill (LTF) is being spread north of the incinerator. Two sections of the four-sectioned impoundment show dark staining (DS). A small (0.04 hectare--0.1 acre) impoundment has been constructed east of the incinerator. The equipment and raw material storage facility continues to expand westward onto the landfill site.

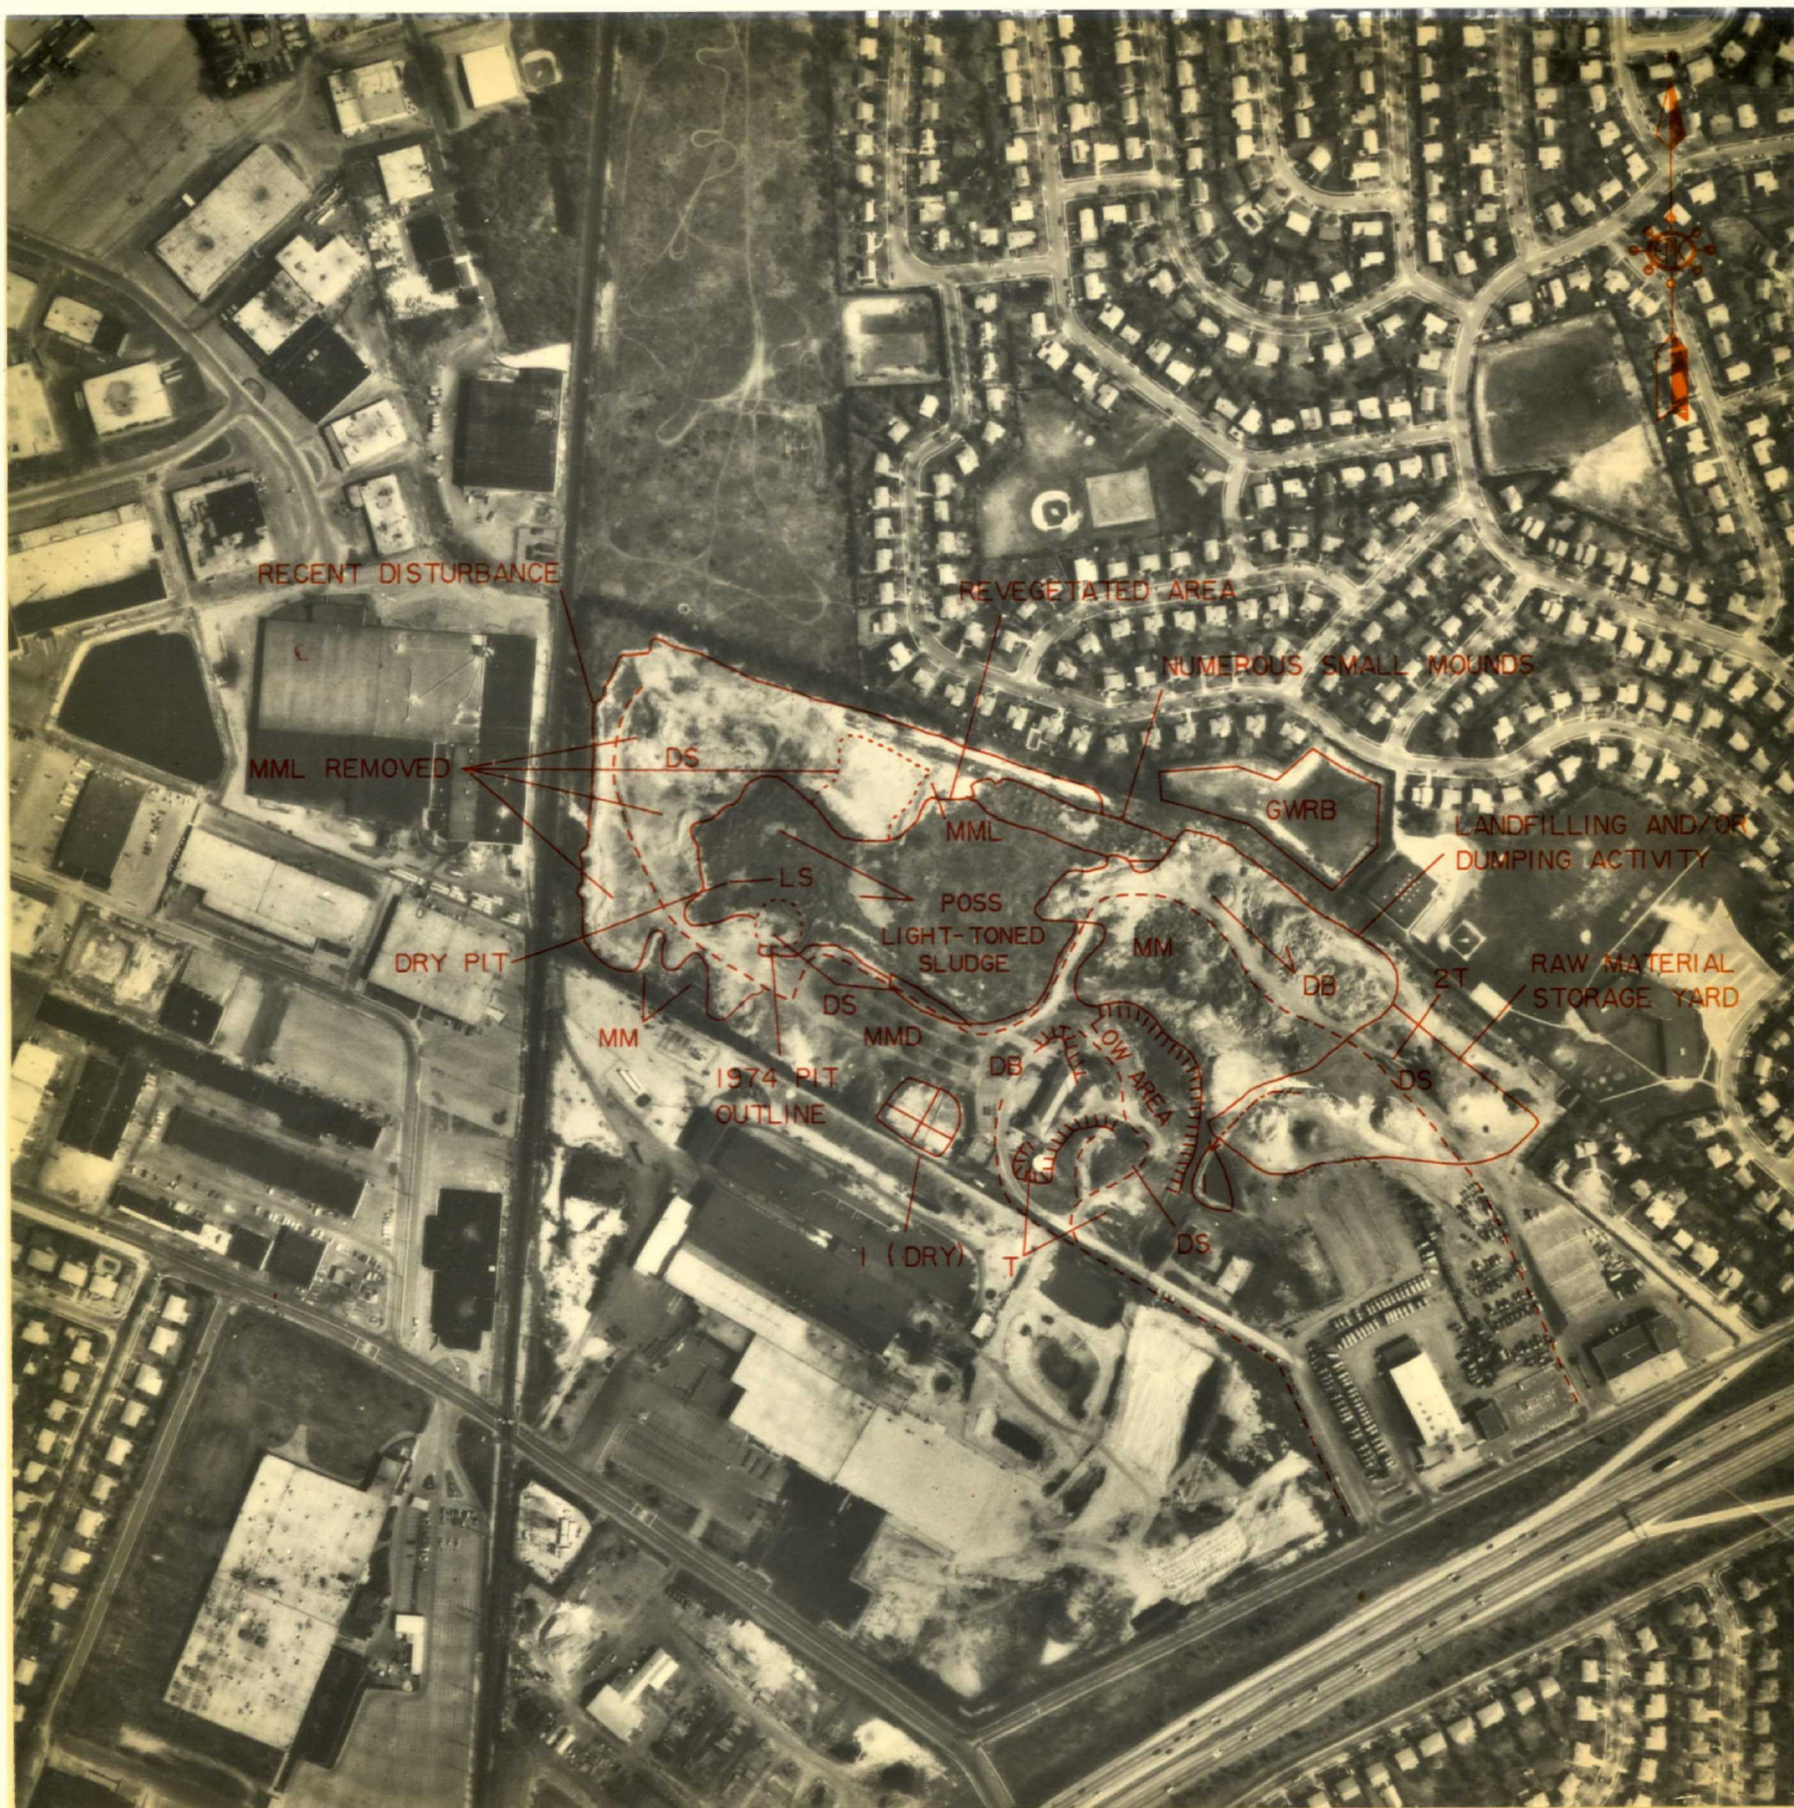
PHOTO II SYOSSET LANDFILL APRIL 17, 1976 APPROX SCALE 1:4,800

Continued disturbance is taking place in the western portion of the landfill in 1976. The mounded light-toned material (MML) seen in 1974 has been removed or graded over the fill by 1976. The liquid-filled pit found south of the vegetated area in 1974 has been filled with light-toned material. Some dark staining (DS) is still visible here. Vegetation is enclosing this old disposal pit. Another shallow, dry pit can be seen west of the 1974 pit. Light staining (LS) is evident in the bottom of the pit. The possible light-toned sludge in the center of the revegetated area is still visible. Twelve piles of mounded dark-toned material (MMD) can be seen near the south central portion of the landfill. Dark staining (DS), which may be liquid disposal, is located along the access road just north of these piles.

The four-sectioned impoundment (I) is dry in 1976. Large scale dumping activity in the east central portion of the landfill is evidenced by the numerous large mounds of earthen material (MM) and debris (DB) present there. The impoundment seen in 1974 is still present. Drainage flows from the raw material storage yard into the impoundment as indicated. Two tanks (T) and dark staining (DS) (possible spillage) can be seen in the raw material storage yard. Another large tank is located southeast of the incinerator. Some dark staining is visible on an access road north of this tank.

- 1976 - (Photo 11) Recent disturbance is occurring in the west where mounded light-toned material (MML) was removed or graded over. The liquid-filled pit seen in 1974 has again been filled. Dark staining (DS) is visible on the access road that leads west on the site. Large-scale dumping has occurred in the eastern section of the site. A large tank trailer can be seen near the site of the 1966 disposal pit.

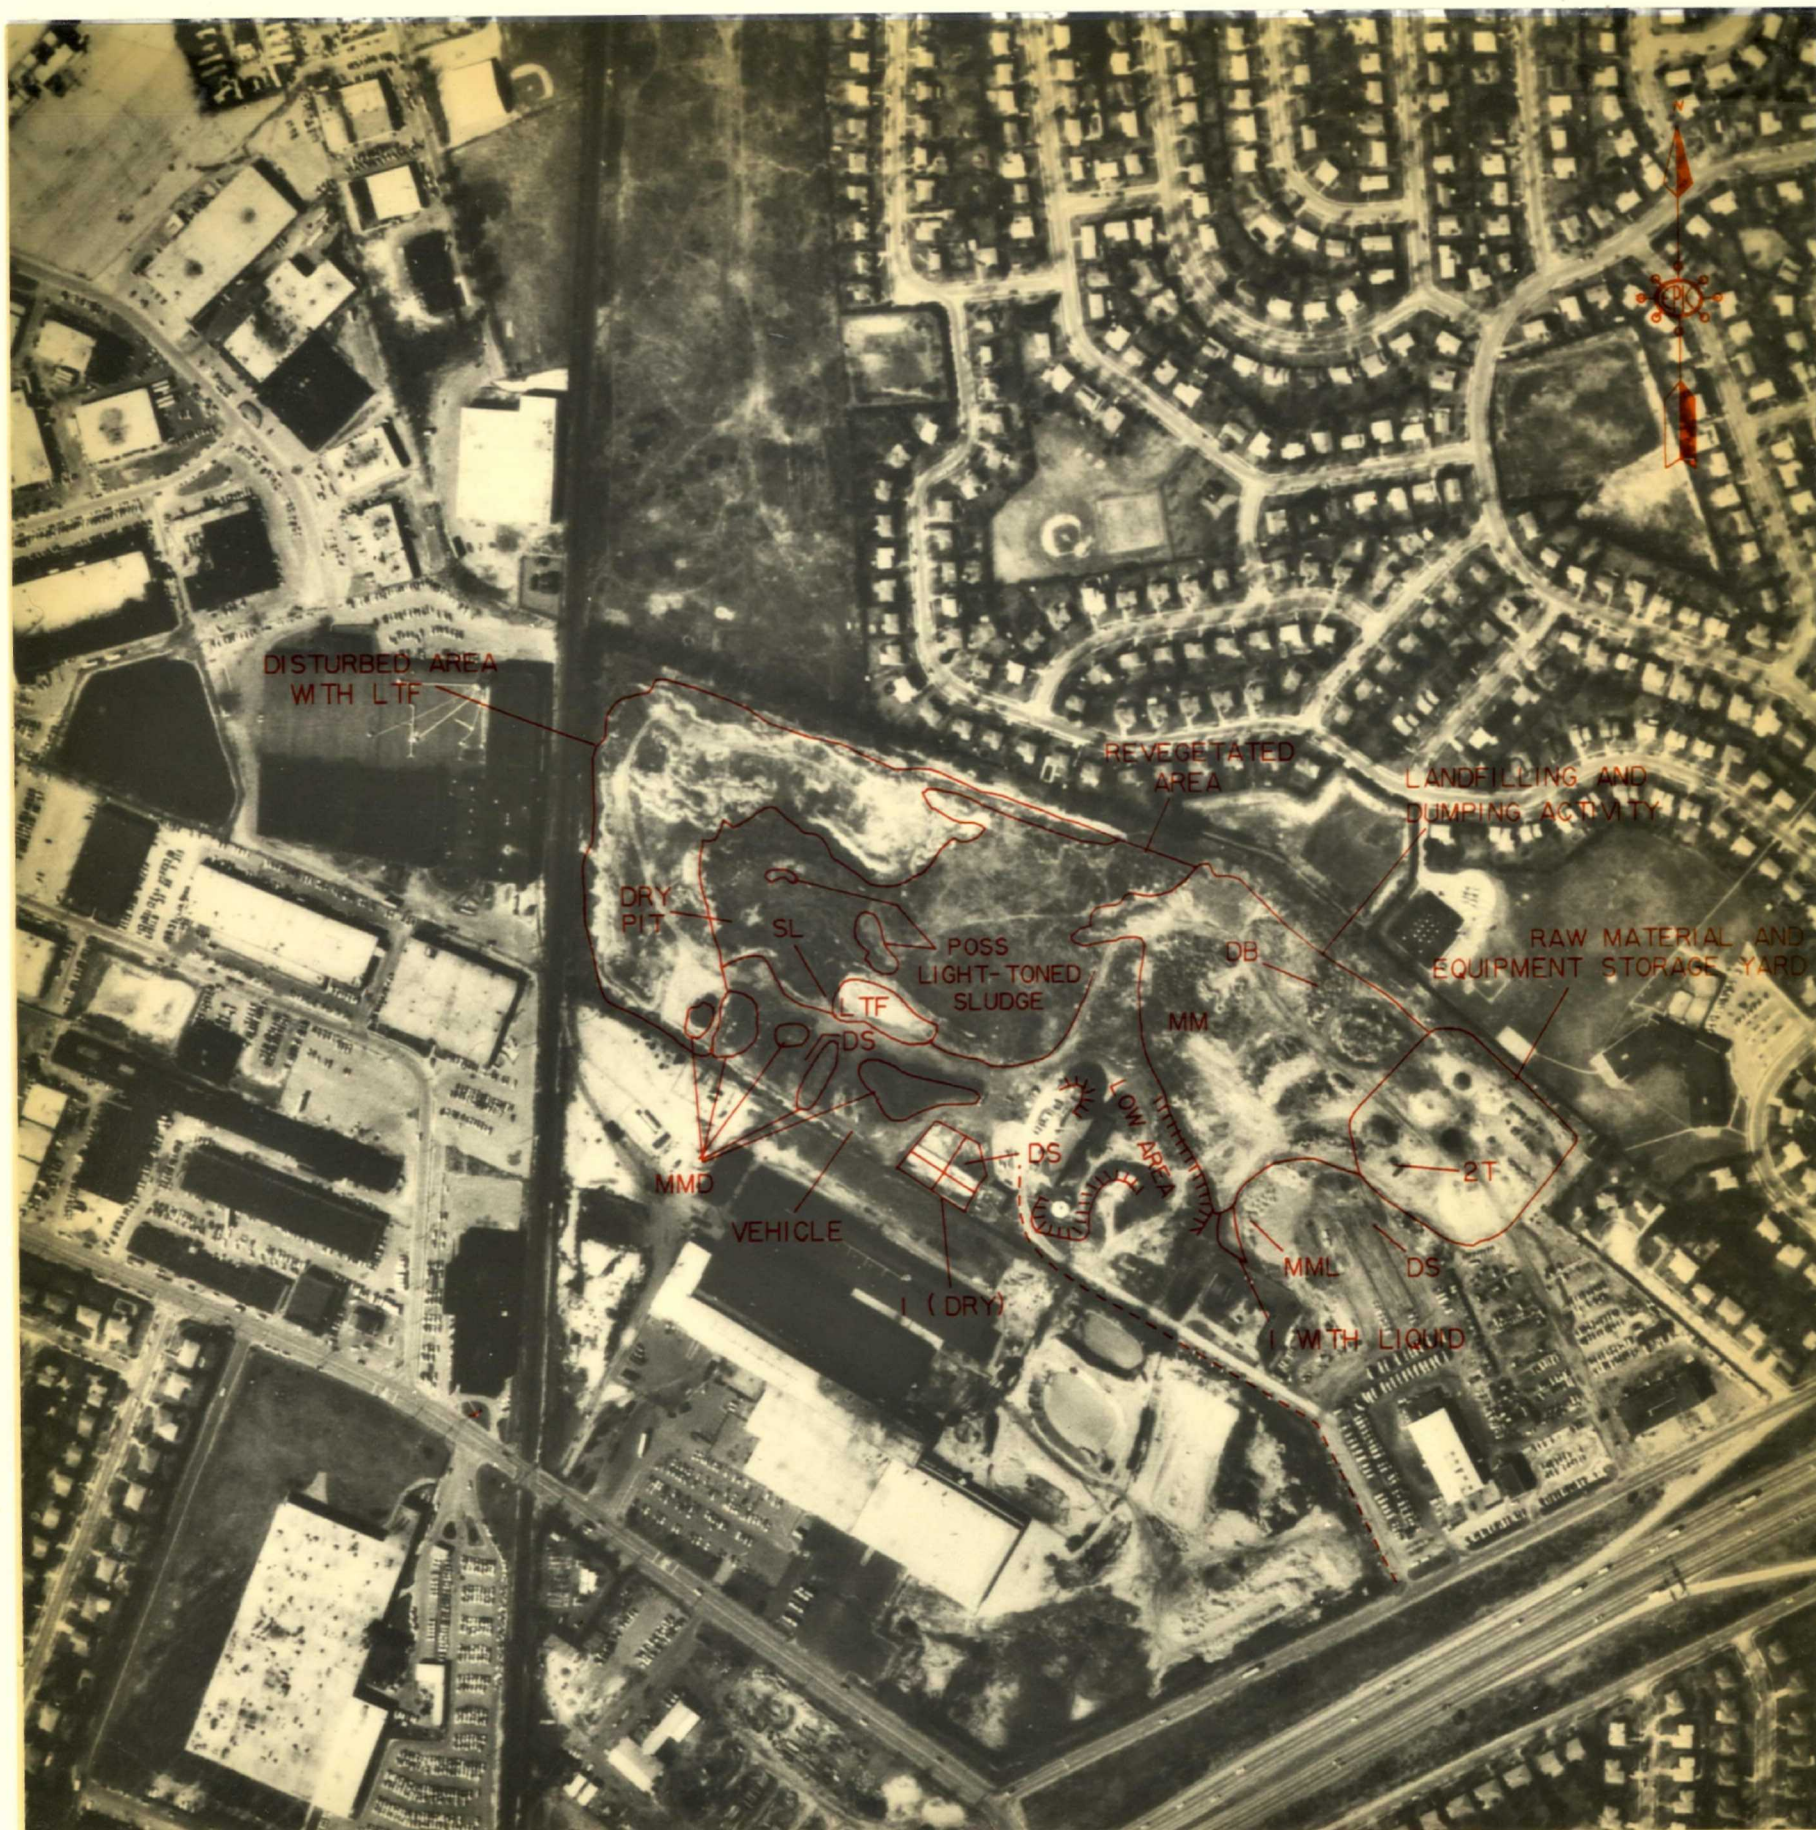
PHOTO 12 SYOSSET LANDFILL MAY 5, 1978 APPROX SCALE 1:4,800

The recent (1974 and 1976) disturbance of the old fill area with its light-toned fill (LTF) and exposed earth is still visible in 1978. The dry pit first seen in 1976 is barely visible. Additional dark-toned mounded material (MMD) has been deposited at the southern edge of the landfill. Some dark staining (DS) can be seen between the mounds. An area of light-toned fill (LTF) has been spread over a portion of the dark stained area seen in 1976; standing liquid (SL) can be seen adjacent to the fill. The possible light-toned sludge is still visible near the center of the site.

The four-sectioned impoundment (I) is dry in 1978. Dark staining (DS) can be seen in the northeast quadrant, and a white residue remains in the other three sections. The dumped earth and debris at the east end of the landfill remain in 1978. Additional piles of raw material, along with two tanks, are being stored in the raw material storage yard. The impoundment (I) first seen in 1974 is being filled with mounded light-toned material (MML) from the east; however, some liquid remains.

- 1978 - (Photo 12) Mounded dark-toned material (MMD) has been deposited in the southwestern section of the site. The eastern section of the fill is similar to its condition found in 1976. The impoundment (I) in the eastern section is smaller due to filling. The tank trailer seen in 1976 is gone.
